**Flood Control Project Maintenance  
Levee Inspections**  
**LMA District Cover Sheet**  
**Spring 2017 Levee Inspection Results**

**Sacramento River West Side Levee District**

| Waterway | | | Bank | Unit Miles |
|--|---|---|---|---|
| Unit No. 01 Sacramento River | | | Right | 49.64 |

**Levee Inspection Report By Mile - Spring 2017**

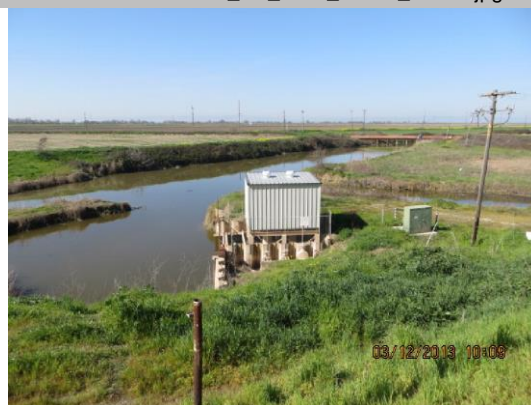
Photo 1 of 3 : UCIP\_SP\_2017\_10087\_17235.jpg

Pumphouse at LS toe.

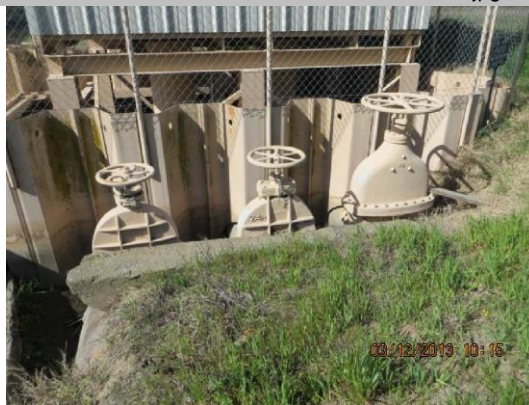
Photo 3 of 3 : UCIP\_SP\_2017\_10087\_17233.jpg

Slide gates at pumphouse on LS toe.

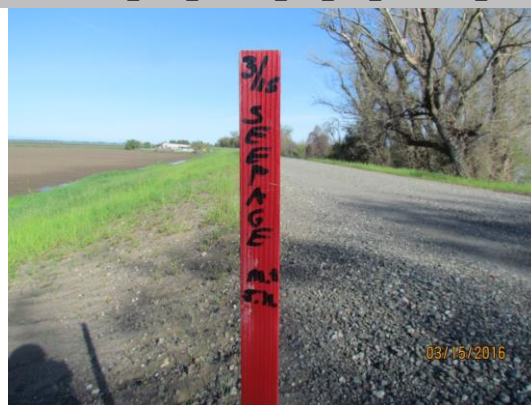
Photo 1 of 2 : SP\_2017\_NA0016\_435\_149\_20170320\_00073.jpg

The monitoring stake is on the shoulder of the levee on the landward side. Spring 2016.

| Seepage area has been staked and noted by LMA. Monitor seepage site. | | | | | |

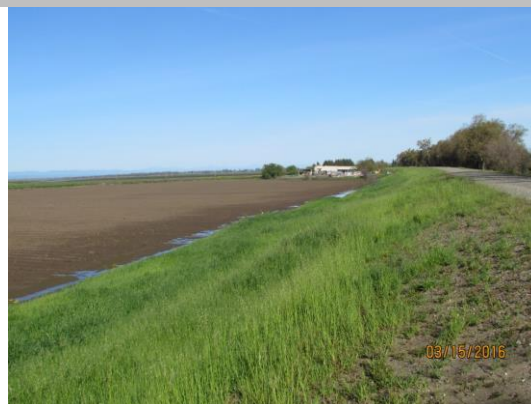
Photo 2 of 2 : SP\_2017\_NA0016\_435\_149\_20170320\_00074.jpg

View of the seepage on the landward side of the levee looking upstream.  
Spring 2016.

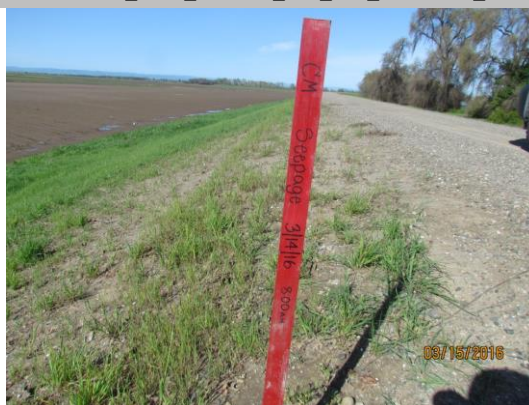
Photo 1 of 2 : SP\_2017\_NA0016\_435\_111\_20170320\_00062.jpg

Stake stating what date the seepage was last monitored. Spring 2016.

| Seepage area has been staked and noted by LMA. Monitor seepage site. | | | | | |

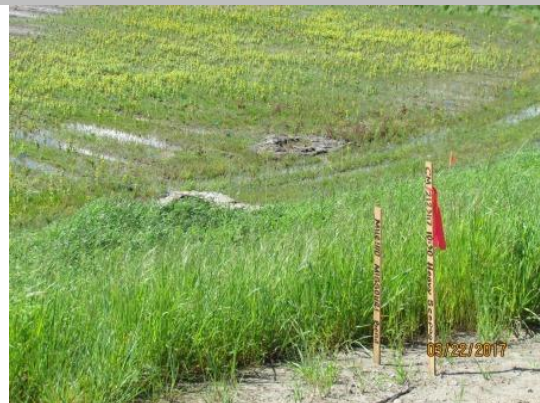
Photo 1 of 1 : SP\_2017\_NA0016\_435\_215\_20170417\_00339.jpg

View of historical boil site at landside levee toe. Two sack rings were placed in February, 2017.

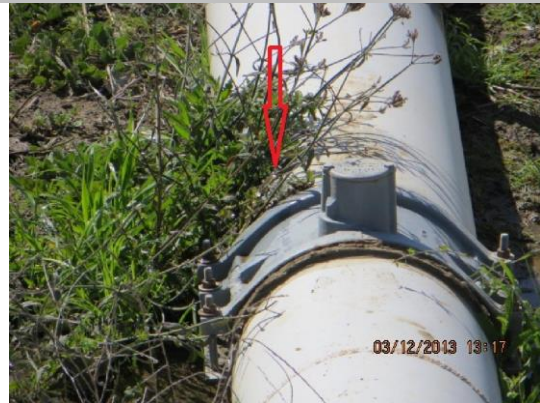
Photo 1 of 3 : UCIP\_SP\_2017\_10129\_17291.jpg

| UCIP Comments: Leak at flowmeter on WS berm may become problem in near future. | | | | | |

Minor leak at flowmeter on WS berm.

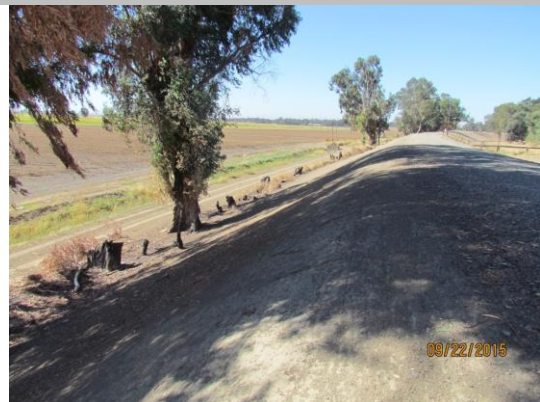
Photo 1 of 1 : SP\_2017\_NA0016\_435\_116\_20170320\_00065.jpg

View of the tree stumps along the landward levee toe looking upstream. Fall 2015.

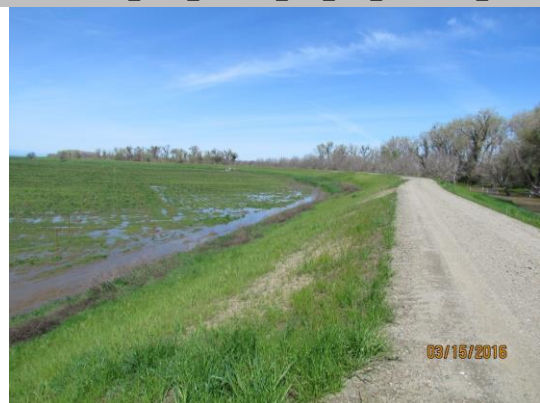
Photo 1 of 2 : SP\_2017\_NA0016\_435\_163\_20170320\_00087.jpg

View of the seepage on the landward side of the levee looking upstream. Spring 2016.

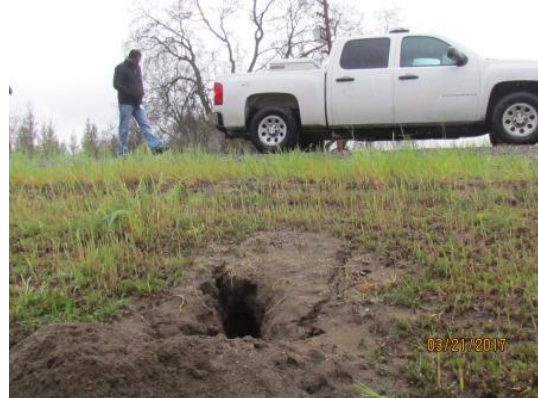
Photo 1 of 1 : SP\_2017\_NA0016\_435\_140\_20170414\_00314.jpg

Large burrow on landside levee slope. Most likely foxes. Spring 2017.

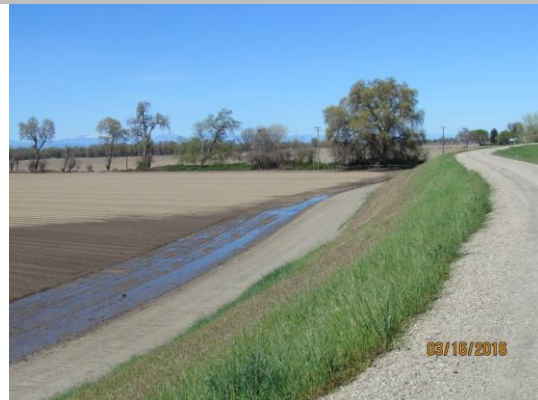
Photo 1 of 1 : SP\_2017\_NA0016\_435\_207\_20170320\_00104.jpg

View of the seepage on the landward side of the levee looking upstream. Spring 2016.

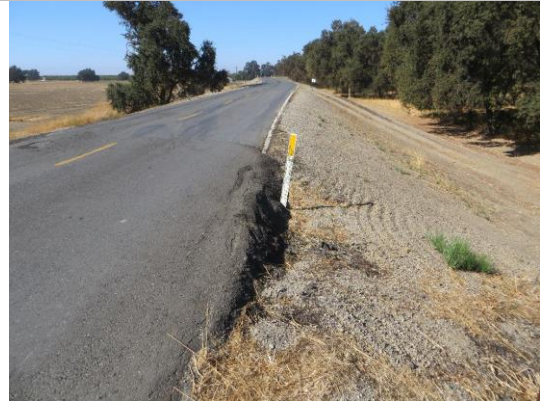
Photo 1 of 3 : UCIP\_SP\_2017\_50044\_74722.jpg

Recent pavement repair showing levee slumping. Photo taken from WS looking upstream along Moon Bend Rd

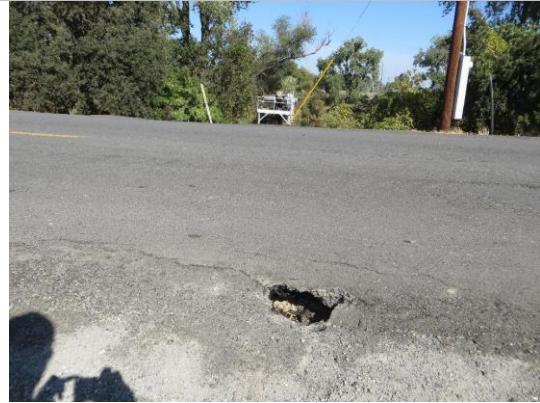
Photo 3 of 3 : UCIP\_SP\_2017\_50044\_74724.jpg

hole in recent pavement repair and LS shoulder along approximate pipe alignment. Photo taken from LS looking toward WS. Pumping plant visible on WS Berm

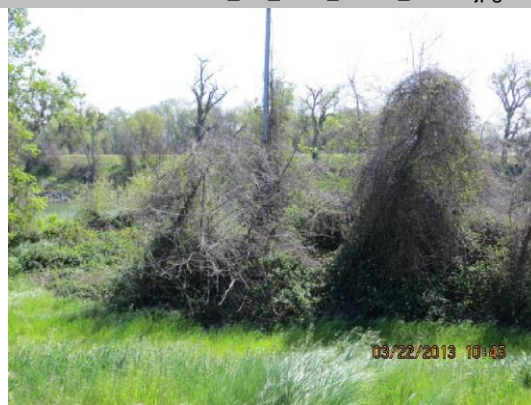
Photo 2 of 3 : UCIP\_SP\_2017\_10566\_17953.jpg

Pump covered in brush on WS berm.
